# BIG UNIT TIMES

## Emergency Repair Experts

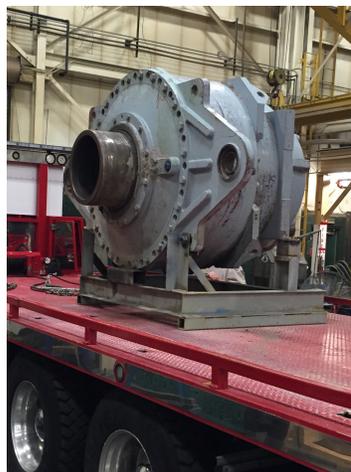
BEFORE

Recently, IDC has been flooded with emergency break downs. One of them came from one of the largest cement mills in the country. One of their raw grind planetary gearboxes was in desperate need of a bearing change out. Because the plant needs to continue to run, we were left with a limited time to do a repair. We received the gearbox on a Monday evening. Our team of mechanics disassembled it and our engineers assessed the damage. We determined that we needed to replace all the bearings and seals, rework a bearing bore, add a couple new keyways, and ceramic coat seal diameters. Once that was completed, we assembled, no load tested, painted, then delivered within 48 hours of receiving it. The box is back at the mill and running great! We plan to do the same repair on the same type of gearbox for this customer in January. Below are before and after photos.

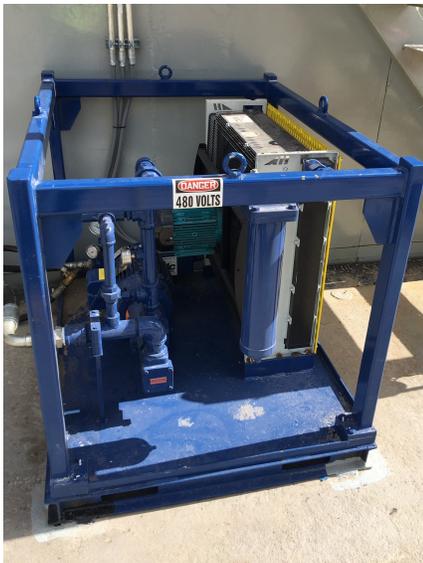
We design and build our own lube skids. Lubrication is extremely important for the longevity of your gearbox. Since we like to see your gearboxes last, we will design a lube skid custom to fit your Big Unit. If your gearbox is running too hot, give us a call at 586-427-4321.

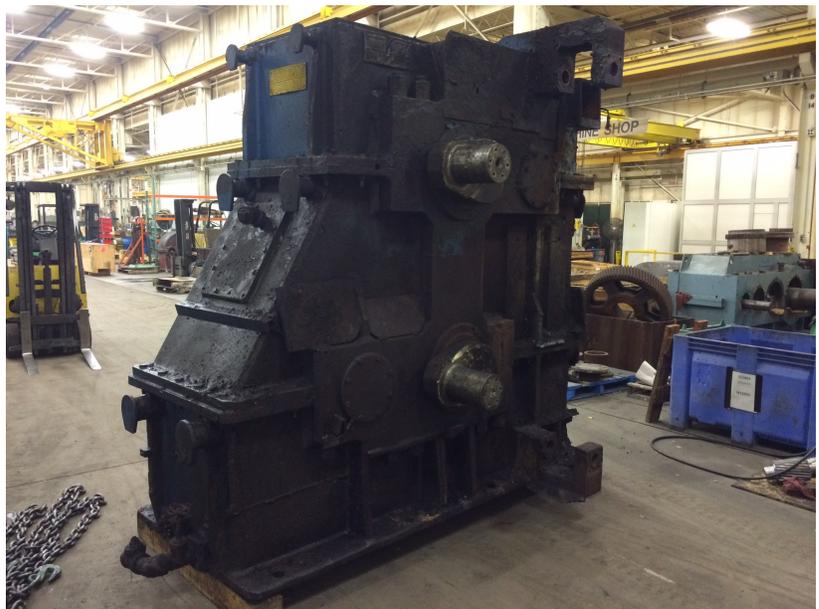
On Friday night after hours, IDC received a shear gearbox from a major steel mill. The input bearings had failed. After disassembly, we inspected all of the gearing in our state-of-the-art Klingelnberg gear checker to confirm it was up to AGMA standards. After inspection, all the gearing was reusable. We were able to restore the housing instead of replacing it by reboring two bearing bores in our shop. This was made possible by our HNK boring mill. After repairing the housing, we replaced bearings and added new spacers. Once assembled, we tested the gearbox under no load, painted, and shipped. It arrived back to the steel mill on Tuesday. We had a team of skilled mechanics working around the clock to get this mill back up and running. At IDC, we understand how costly customer's down time can be. As a result, IDC invests in state-of-the-art equipment and effectual personnel to minimize customer down time. This was another satisfied customer and a victory for the IDC team. Below you can see a photo of the gearbox as we received it.
